CONTRACT NO. DE-AC27-01RV14136 – LOW-ACTIVITY WASTE BASEMAT COLD JOINT

Enclosed are the formal submittal of the report (Attachment 1) and the Olson Report, "Final Concrete Condition Assessment Report Southeast Foundation Slab Cold Joint Evaluation," (Attachment 2) which was previously submitted in draft.

**FINAL CONCRETE CONDITION ASSESSMENT REPORT
SOUTHEAST FOUNDATION SLAB COLD JOINT EVALUATION
LOW ACTIVITY WASTE STRUCTURE
DOE HANFORD WASTE VITRIFICATION PROJECT
HANFORD, WASHINGTON**

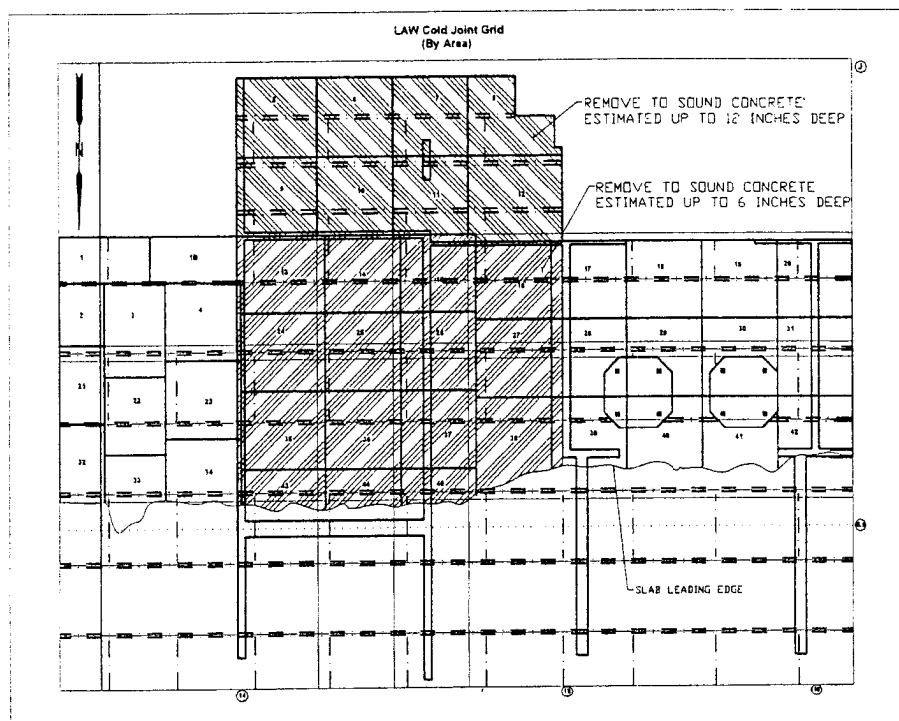
Initial NDE testing was conducted September 24-26, 2002 by Mr. Raparelli with assistance of Bechtel personnel to determine where additional chipping would be required to remove all questionable quality concrete. The NDE utilized included the Impact Echo (IE) test method with an Olson Instruments Concrete Thickness Gauge (Model CTG-1TF). Initial NDE results found good quality concrete in the full-thickness sections of the 5 ft thick slab at the south end. The Impact Echo (IE) tests predicted nominally a 5 ft thick slab with a sound (compressional) wave velocity indicative of good quality concrete. Similar good IE thickness (adjusted for concrete removal) and Spectral Analysis of Surface Wave (SASW) velocity results were found in east and west portions of the sloping cold joint slab that indicate the remaining concrete is of good quality. However, areas of near-surface poor quality, weak concrete still remained in the north-central portions of the slab. In these areas, IE tests did not always result in a thickness echo due to questionable quality, weak concrete at the surface. Additional chipping was subsequently performed by Bechtel in the cold joint areas to depths of up to 3 inches. The locations and conservative estimated maximum depths of chipping can be found in Fig. 1 below.

Figure 1 - Areas of additional chipping after initial NDT results

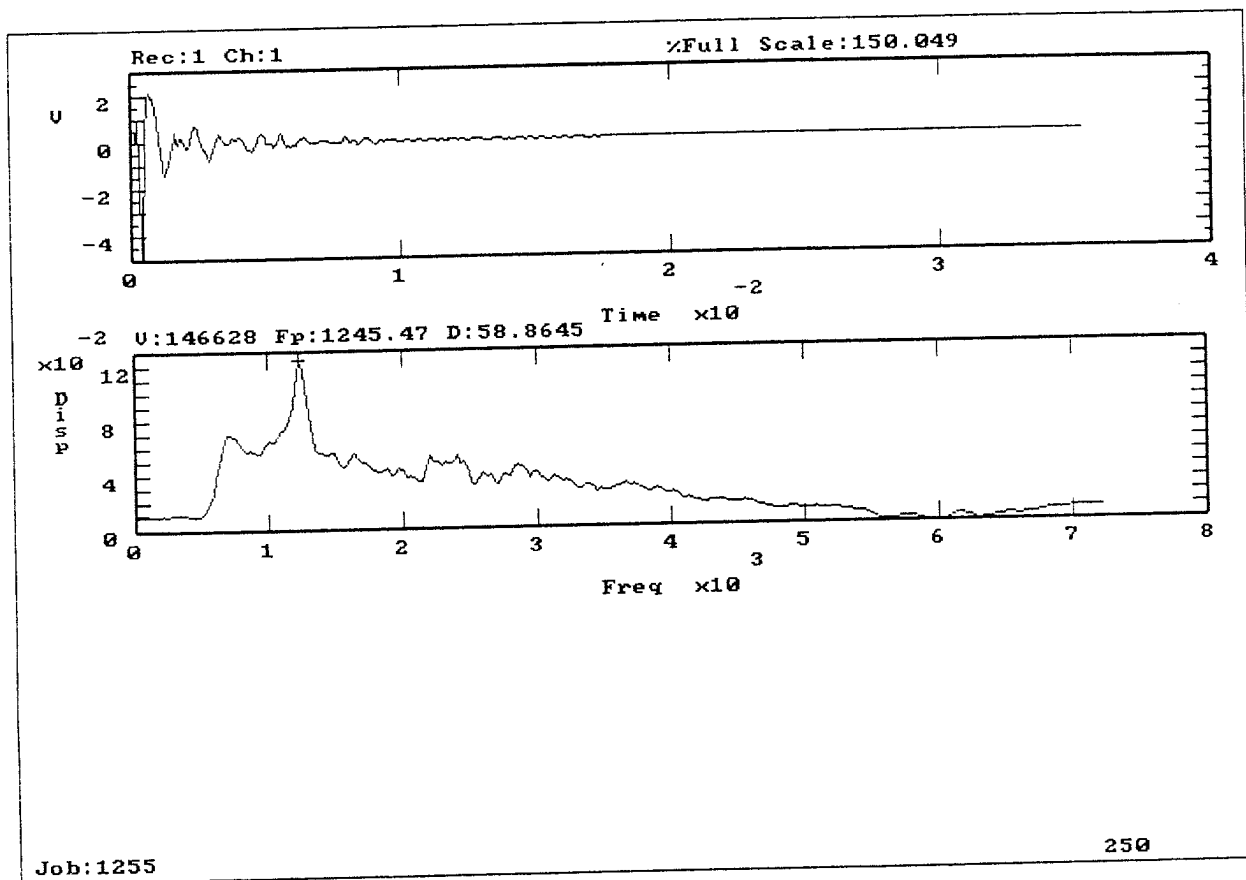
Figure 4 shows example data recorded on the CTG during an IE test at point D42. The top plot shows transducer displacement versus time. The second plot is the spectra of the data and shows the frequency domain thickness peak at 58.9 inches (echo frequency of 1245 Hz). The expected thickness of the slab was 60 inches. The IE velocity used during testing was 12,219 fps or 146,628 inches per second.

CMD: Accept Reject Loop Prt Sub Meas Chan Var Filter Zoom Toggle Outfile Nxtset
Figure 4 - Full Thickness IE test at test location D42

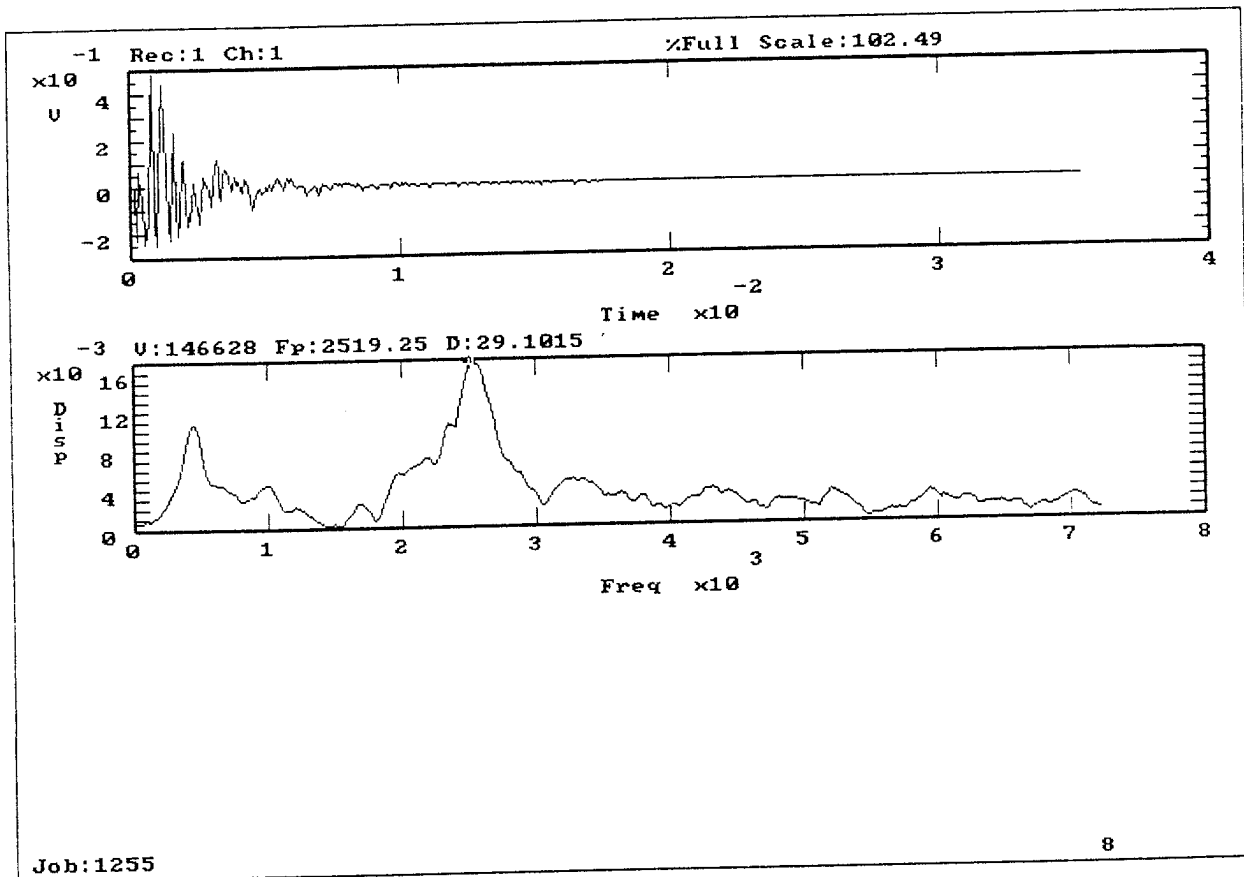
Figure 5 shows example data recorded on the CTG during an IE test at point Y45 in the chipped portion of the slab. The top plot shows transducer displacement versus time. The second plot is the spectra of the data and shows the frequency domain thickness peak at 29.1 inches (echo frequency of 2519 Hz). The expected thickness of the slab was 25 to 29 inches in this area of the cold joint.

CMD: Accept Reject Loop Prt Sub Meas Chan Var Filter Zoom Toggle Outfile Nxtset
 Figure 5 - Partial Thickness IE test in the cold joint at test location Y45

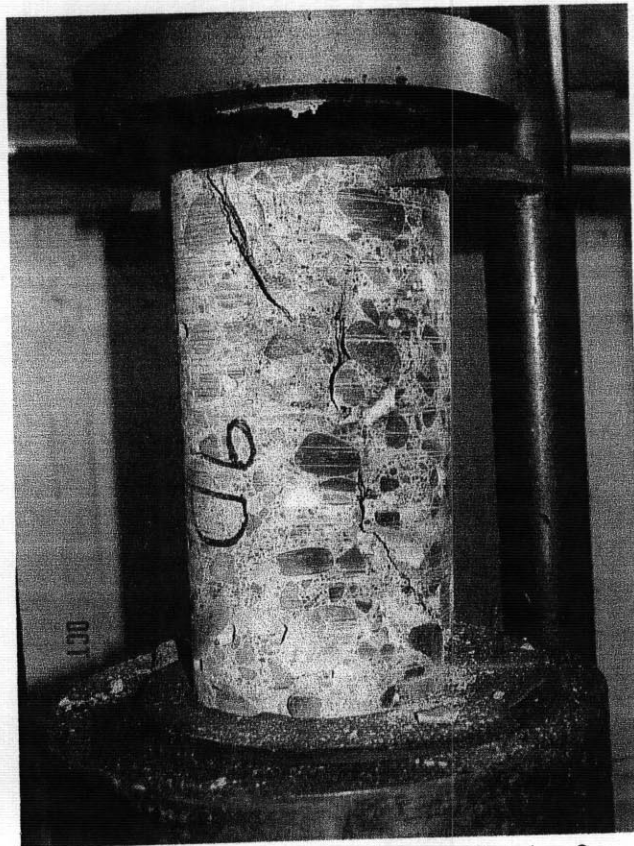
Figure 10 - Core Sample 9D immediately after failure

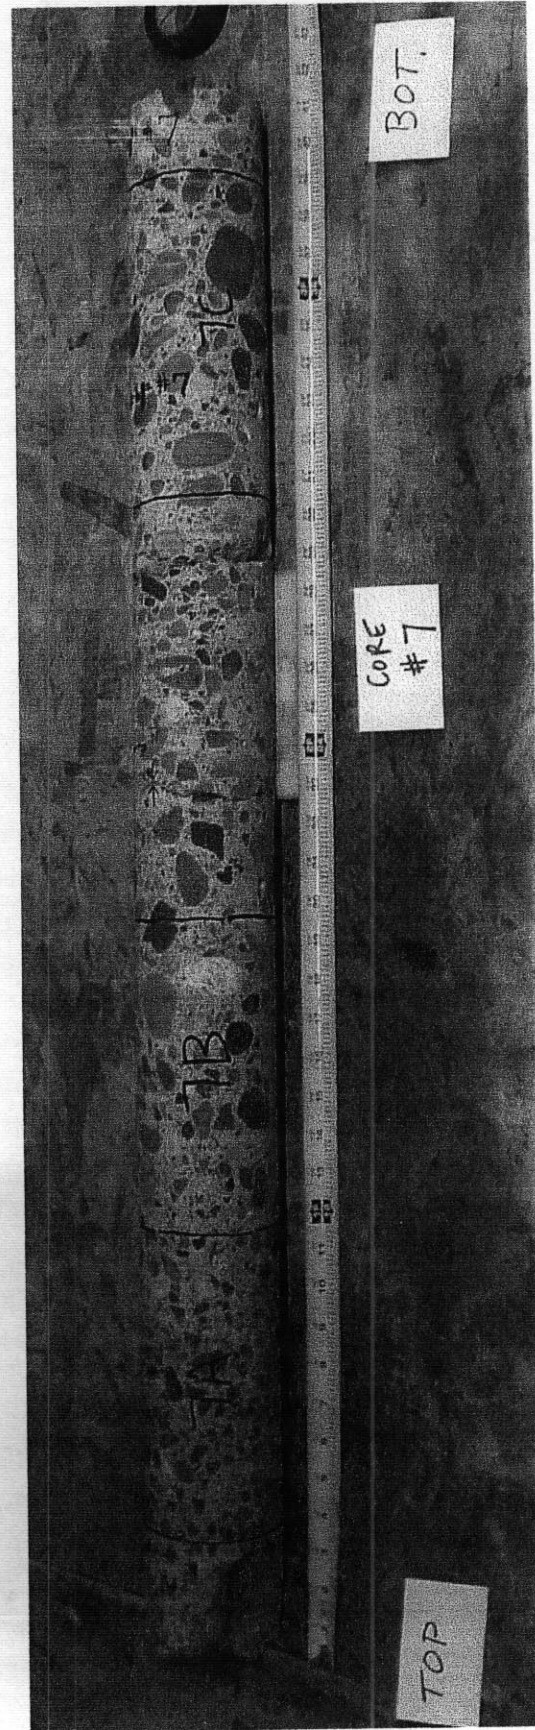
Figure 14 - Core #7, core broke between sections 7B and 7C

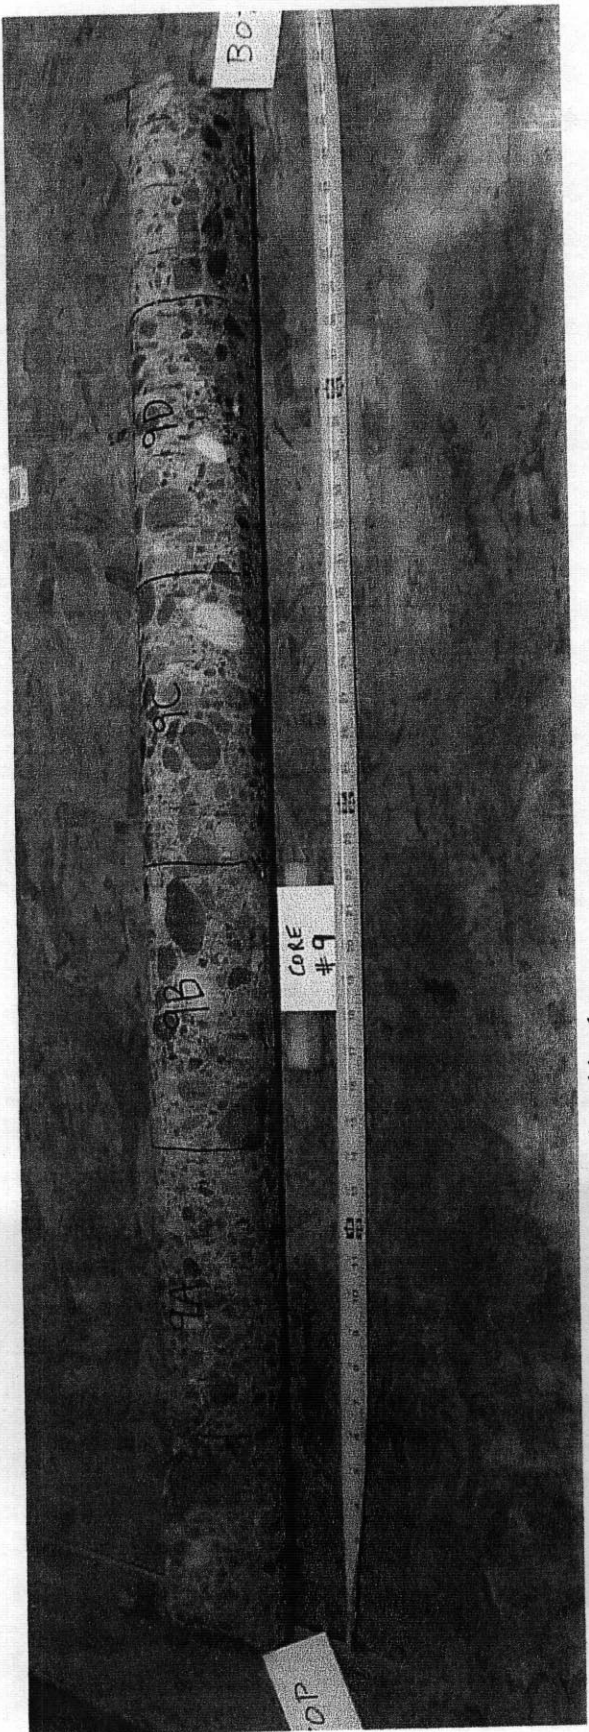
Figure 17 - Core #9, top 3 to 5 inches cracked and broke

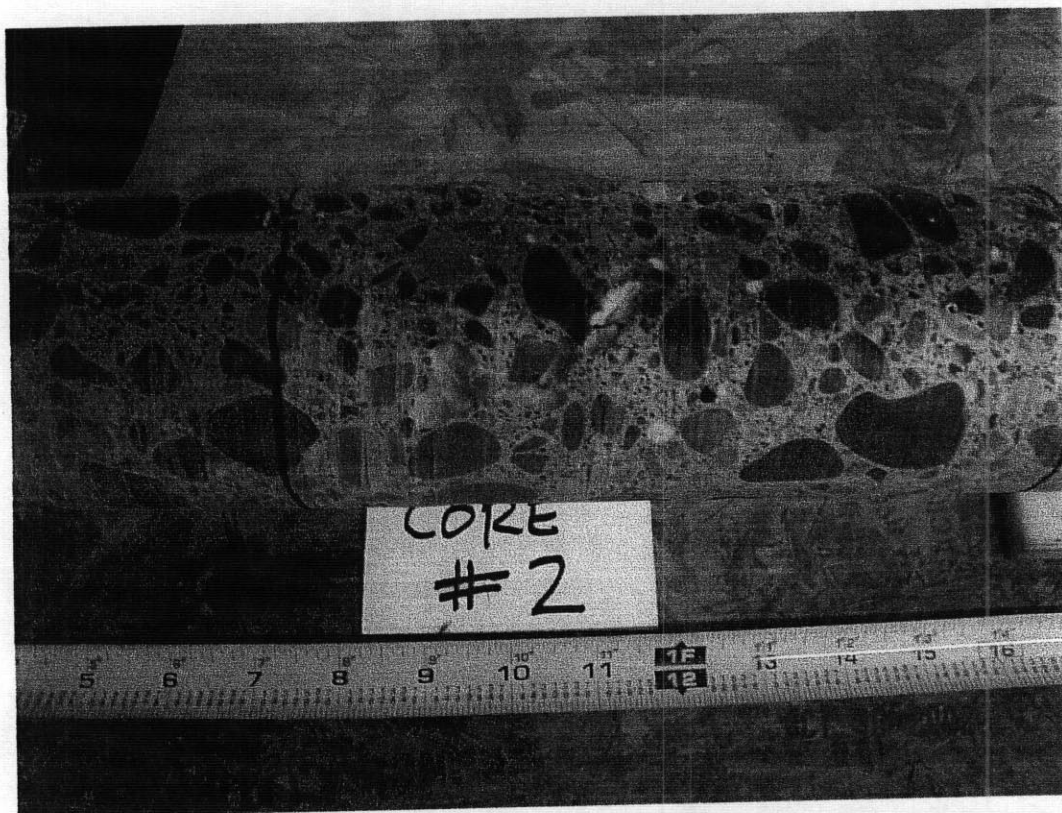
The core locations did not correspond exactly to the initial NDT test locations. This was due to access constraints as a result of the dense rebar spacing. The core locations did, however, adequately cover the areas of concern. Direct observation of the core samples did not show appreciable depths of questionable quality concrete. The ease at which both manual and mechanical chipping removed the upper layers of concrete, however, suggest weak concrete does exist in the shallow layers of the slab. Some cores did contain minor, isolated voids, as noted in Table II, but not to an extent greater than expected in normal good quality concrete. The results of the density tests support this assertion, with an average density of 152.1 pcf. Photographs of cores and typical voids can be found in Appendix C.

Figure 19 - Example Voids from Core #2

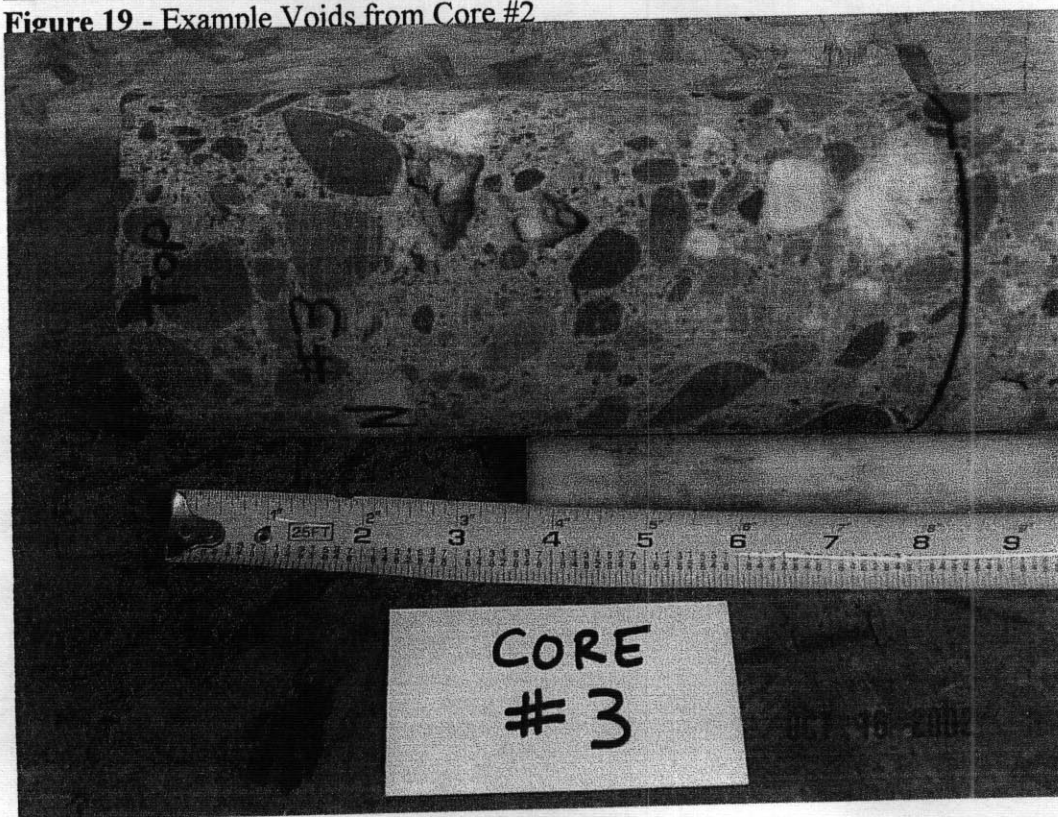
Figure 20 - Example Voids from Core #3

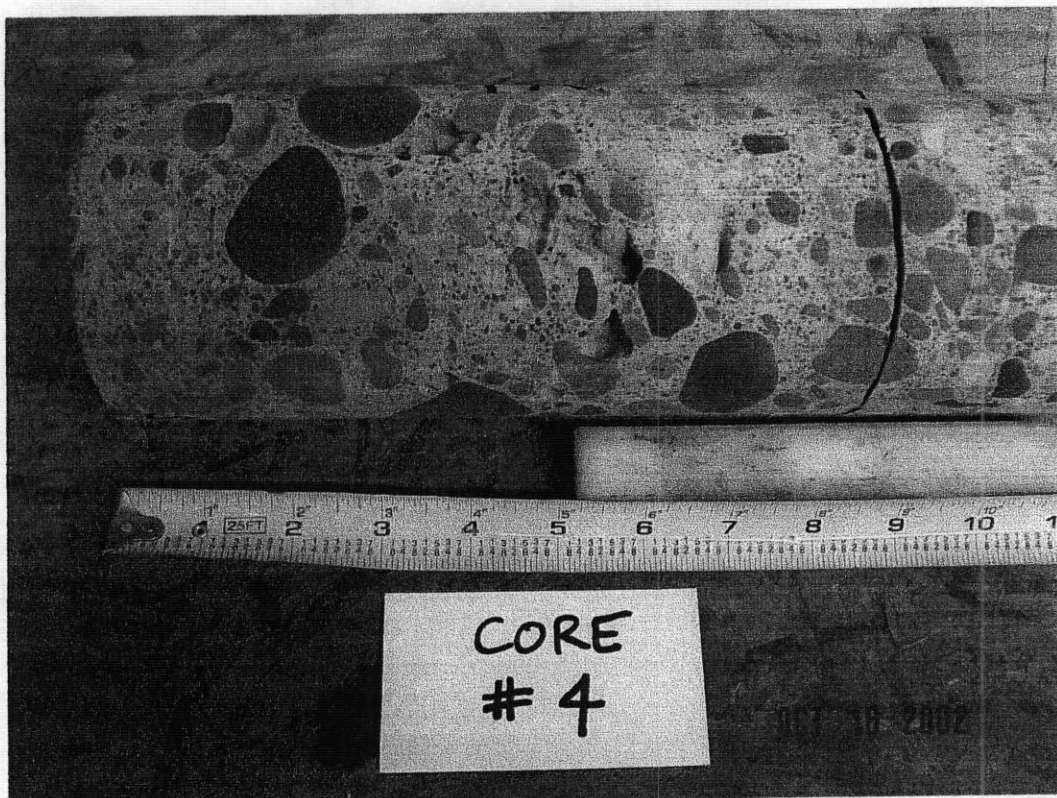
Figure 21 - Example Voids from Core #4

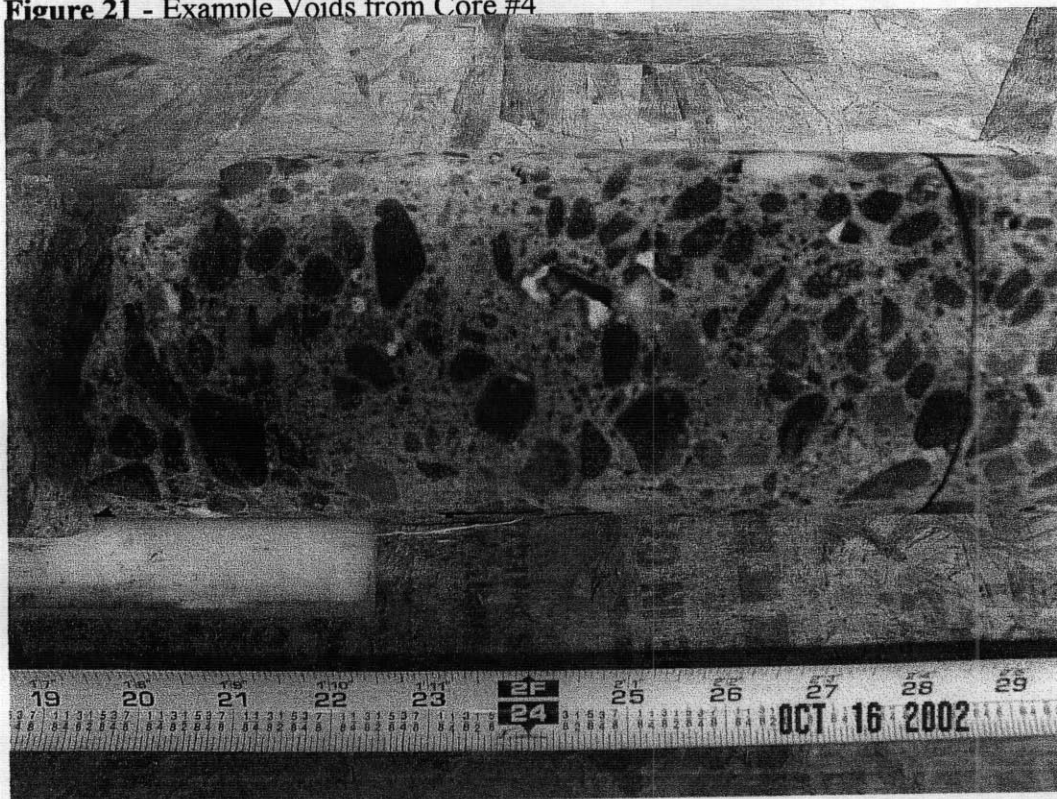
Figure 22 - Example Voids from Core #5

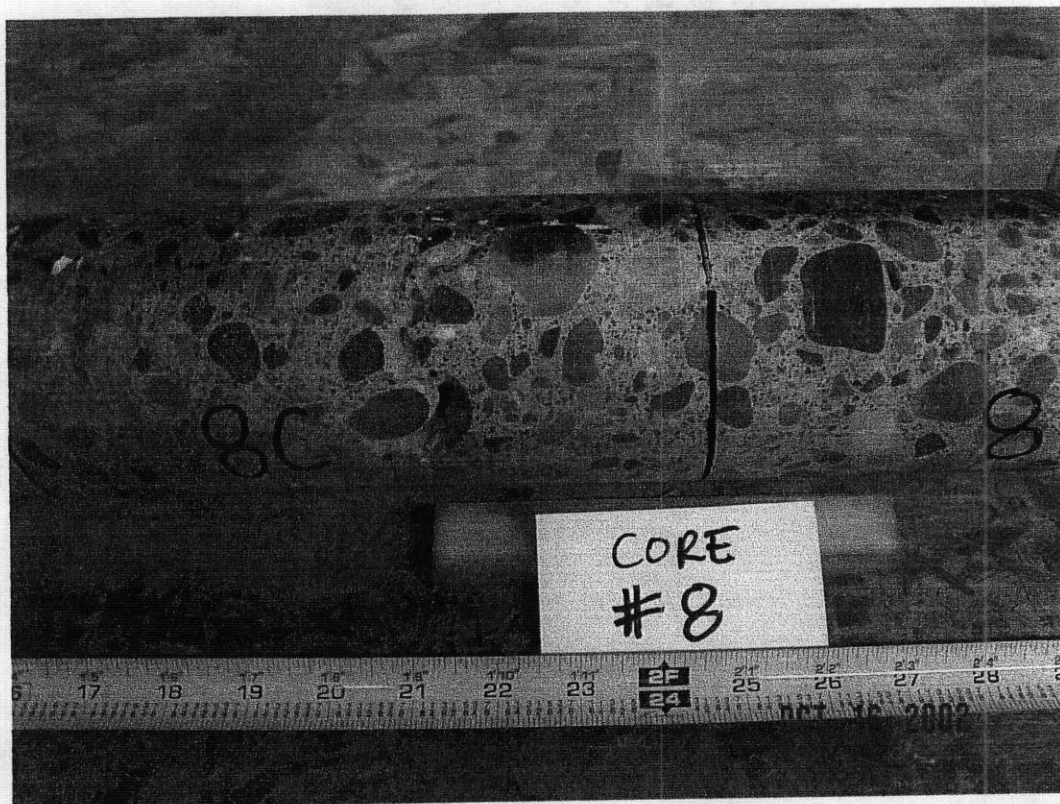
Figure 23 - Example Voids from Core #8

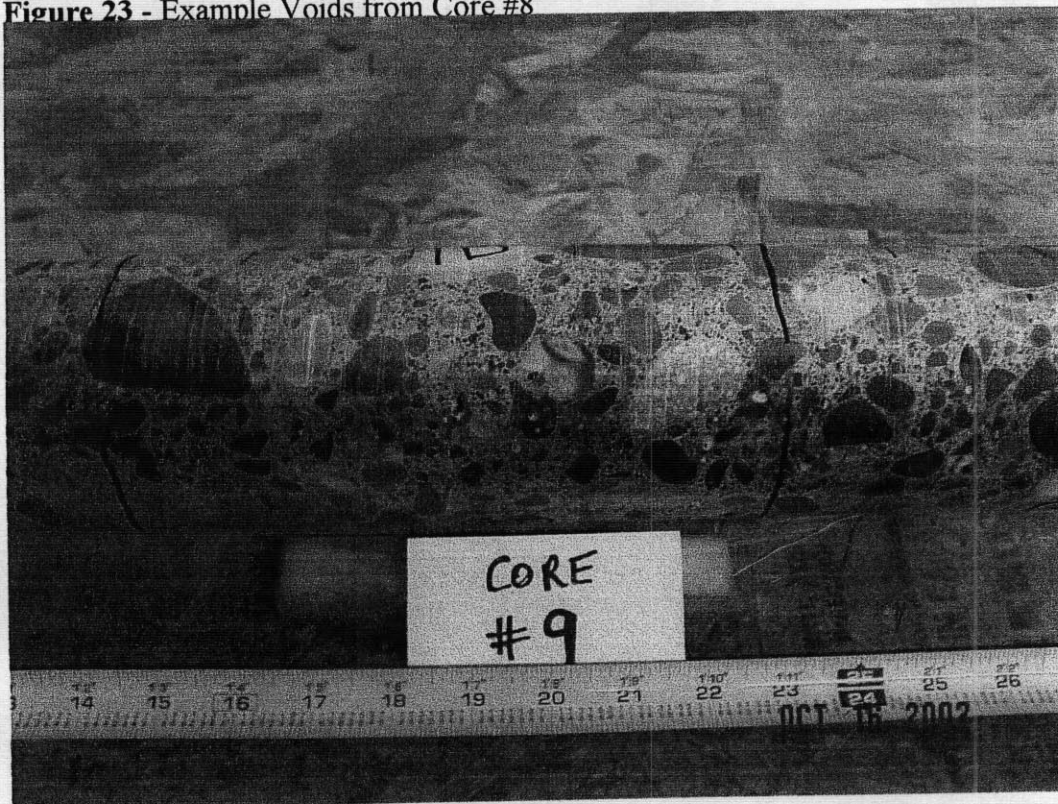
Figure 24 - Example Voids from Core #9
